**ICICLE CREEK
AND THE
LEAVENWORTH NATIONAL FISH HATCHERY**

January 12, 2014

This forty-two page summary is a brief history of the relationship between Icicle Creek and the Leavenworth National Fish Hatchery.

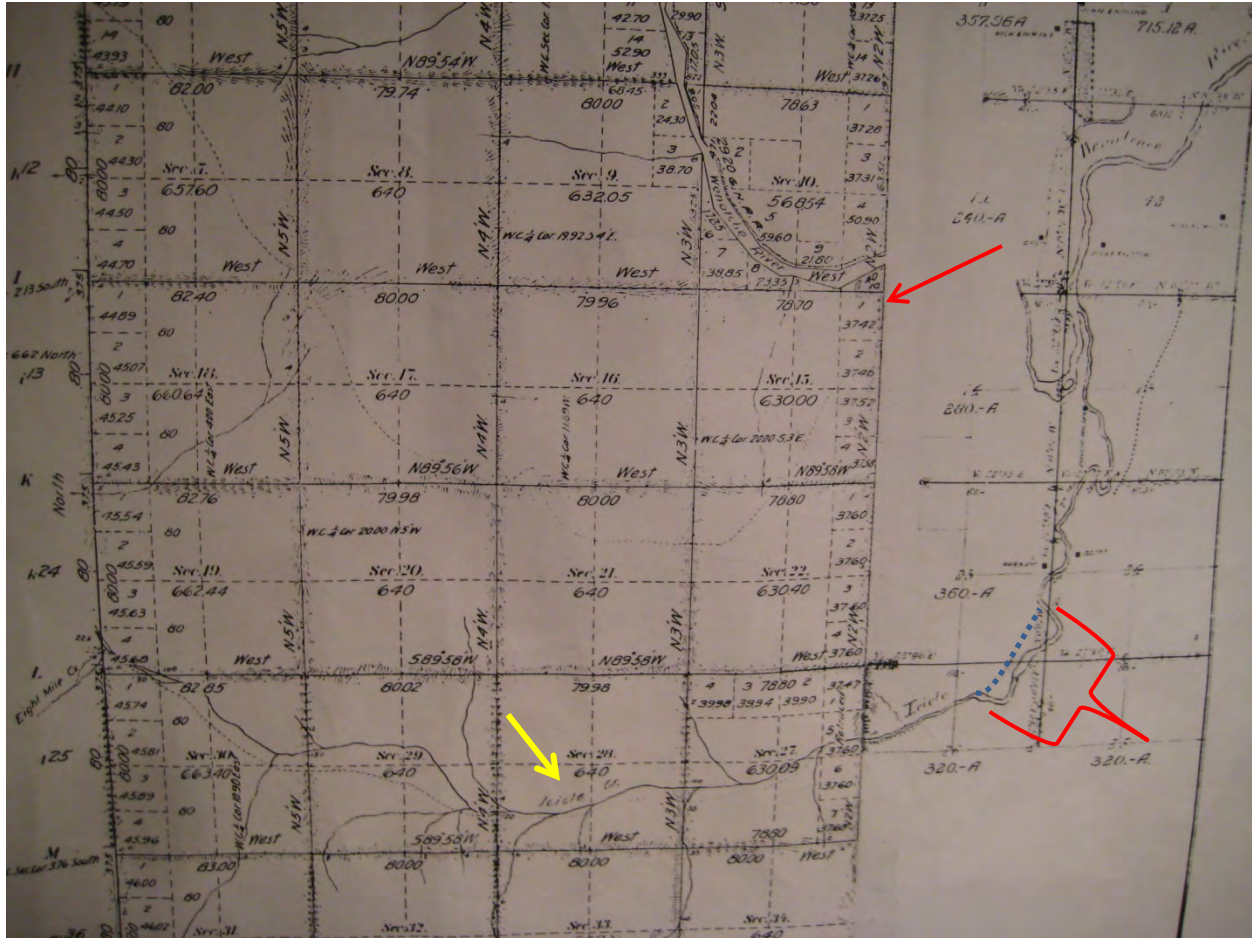
(Figure 1) This photo is of two early survey maps of Icicle Creek taped together along the line pointed to by the red arrow. Both maps were surveyed in 1892.

The red bracket shows the reach between RM 3.8 and RM 2.8 of the natural bed of Icicle Creek. The blue dotted line shows where the Hatchery Canal was built. The yellow arrow points to the name of the stream (Icicle Cr.) This survey was taken 46 years before the Hatchery Canal was built. The reach in the bracket has recently been referred to as the “side channel” of Icicle Creek. In 1892 this reach was accepted as Icicle Creek.

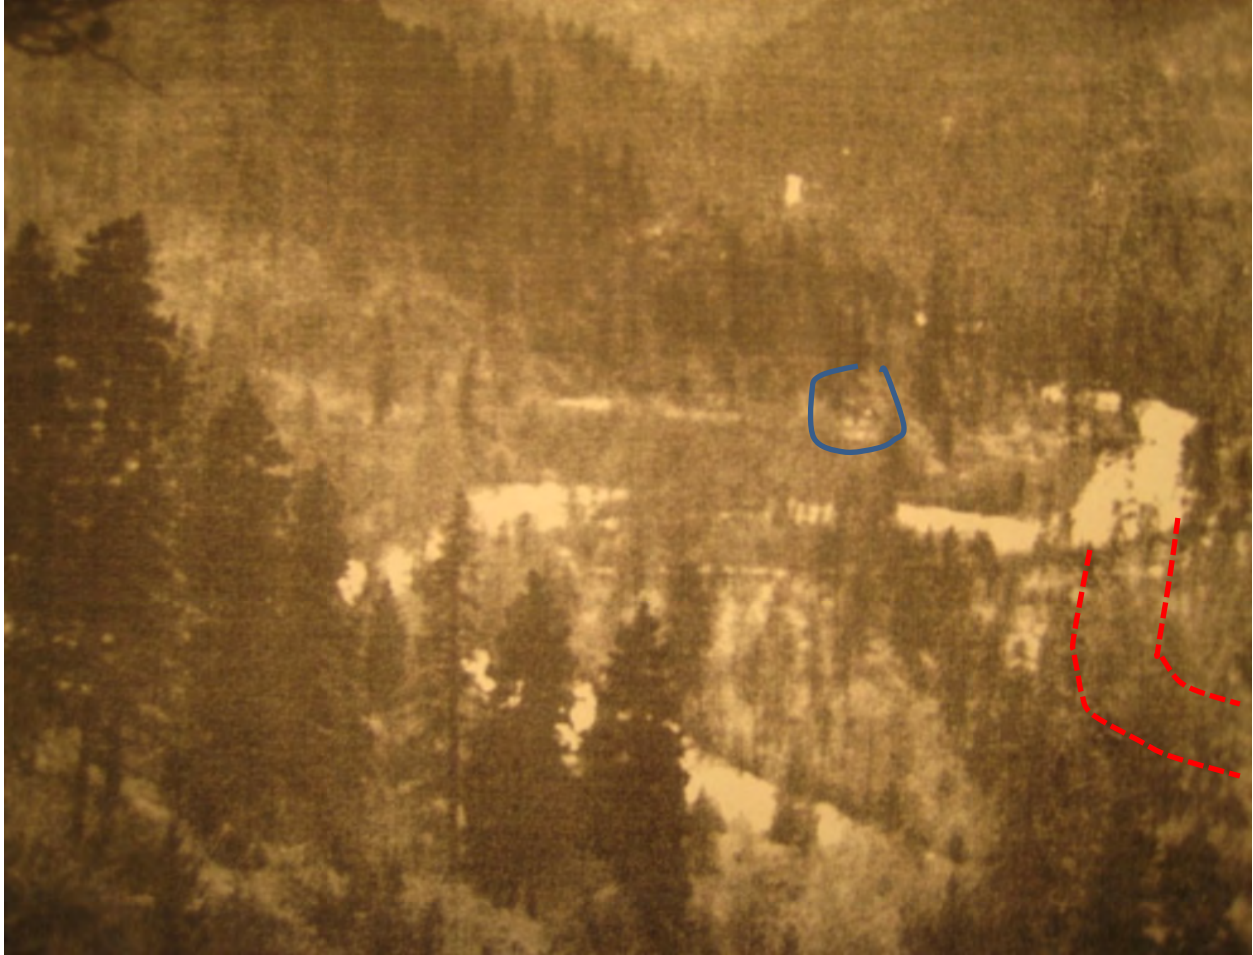
(Figure 2) This photo was taken around 1925 facing southwest (before construction of the Hatchery) of Icicle Creek from the west-facing hillside above the stream and to the east of the stream. Harriet Bullitt's current residence can barely be seen located across the river in the upper right ¼ of the photo (circled in blue)

The area appears to have been logged. A wagon road can be seen approaching the building. Most of this road exists today.

Two red parallel dotted lines are drawn where the canal was built in 1939.

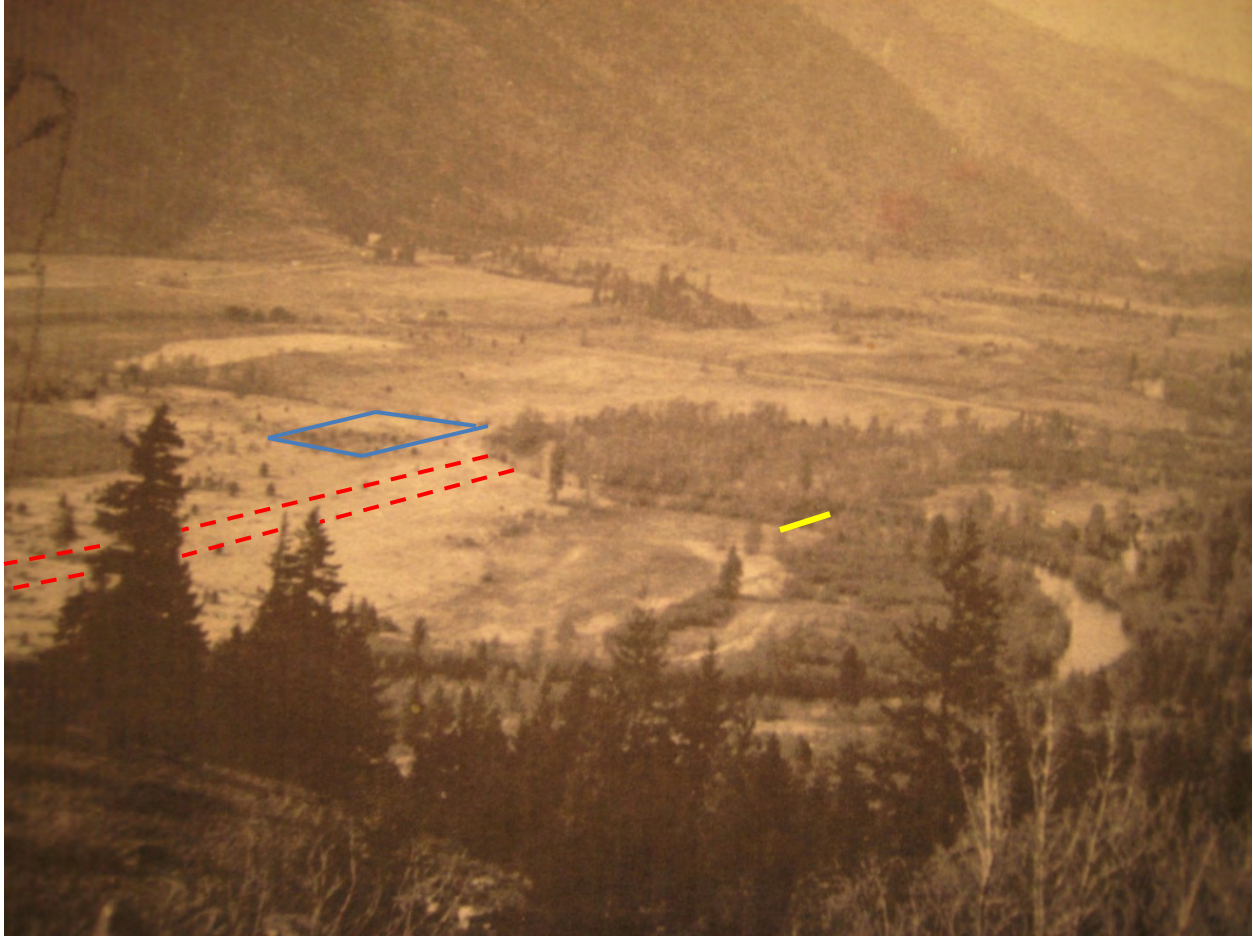
(Figure 3) This photo was taken around 1925 from the same hillside as the photo in figure 2 except it is taken looking northwestward. It is a photo of the Leavenworth Valley. Most all of the trees have been cut down to make way for farming.

The entrance to Tumwater Canyon can be seen in the upper right of the photo.

The Hatchery Canal has not yet been built. The Canal was excavated across the flat area to join Icicle Creek at the bend just to the left of the large tree. Two dotted parallel red lines show the approximate location of the canal. A blue rectangle has been drawn to show where the Hatchery was built. The location of Dam 5 is shown in yellow.

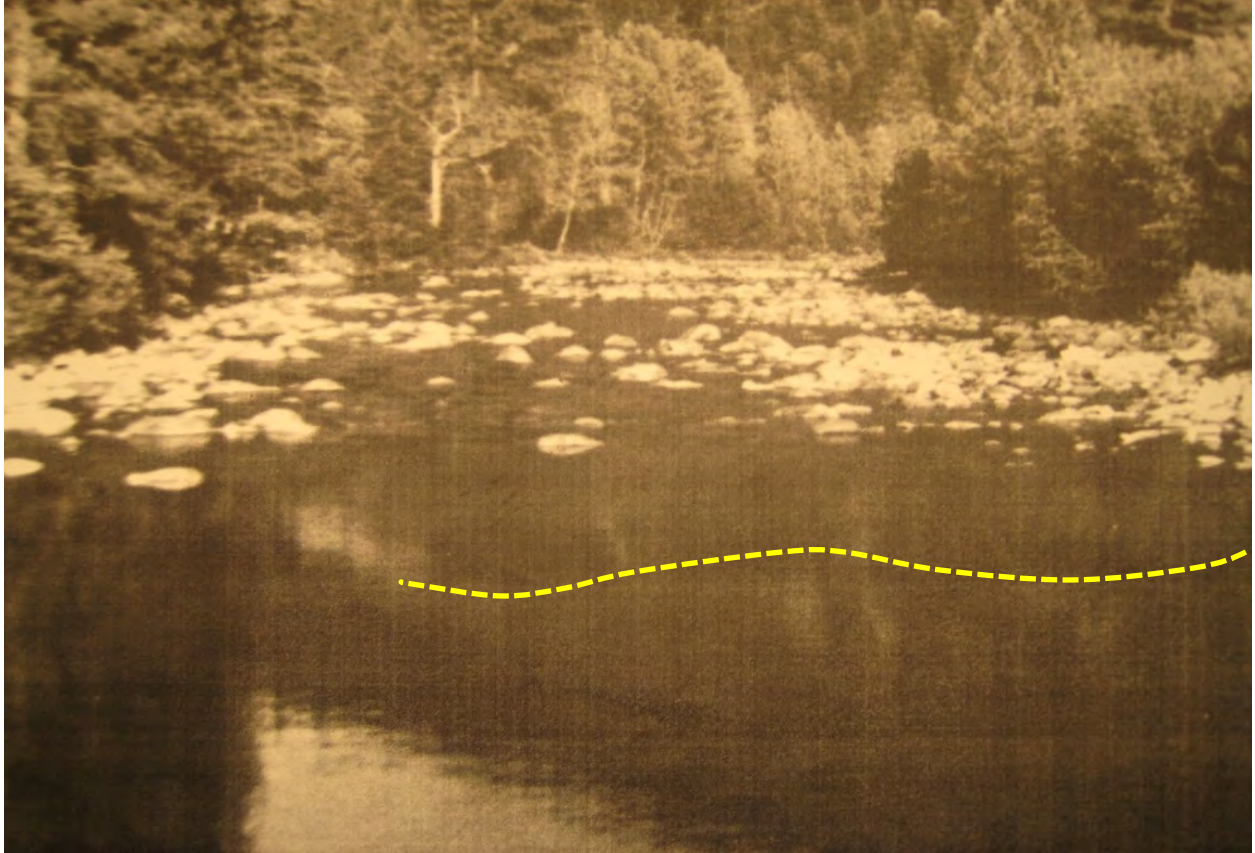
(Figure 4) This photo of Icicle Creek, looking downstream in the area where Dam 2 (Headgate Dam) is now located, was taken around 1929.

It is easy to see the low lying topography on the left bank of this photo that allowed Icicle Creek to leave the main channel and spread out northeastward (toward the upper left corner of the photo) during floods.

Bedrock forms the bottom of Icicle Creek in this photo and is shown by a dotted yellow line.

It is obvious that the canal leaves the flood formed topography cutting through higher topography outside the floodplain. Compare to Figure 4, taken in 1929.

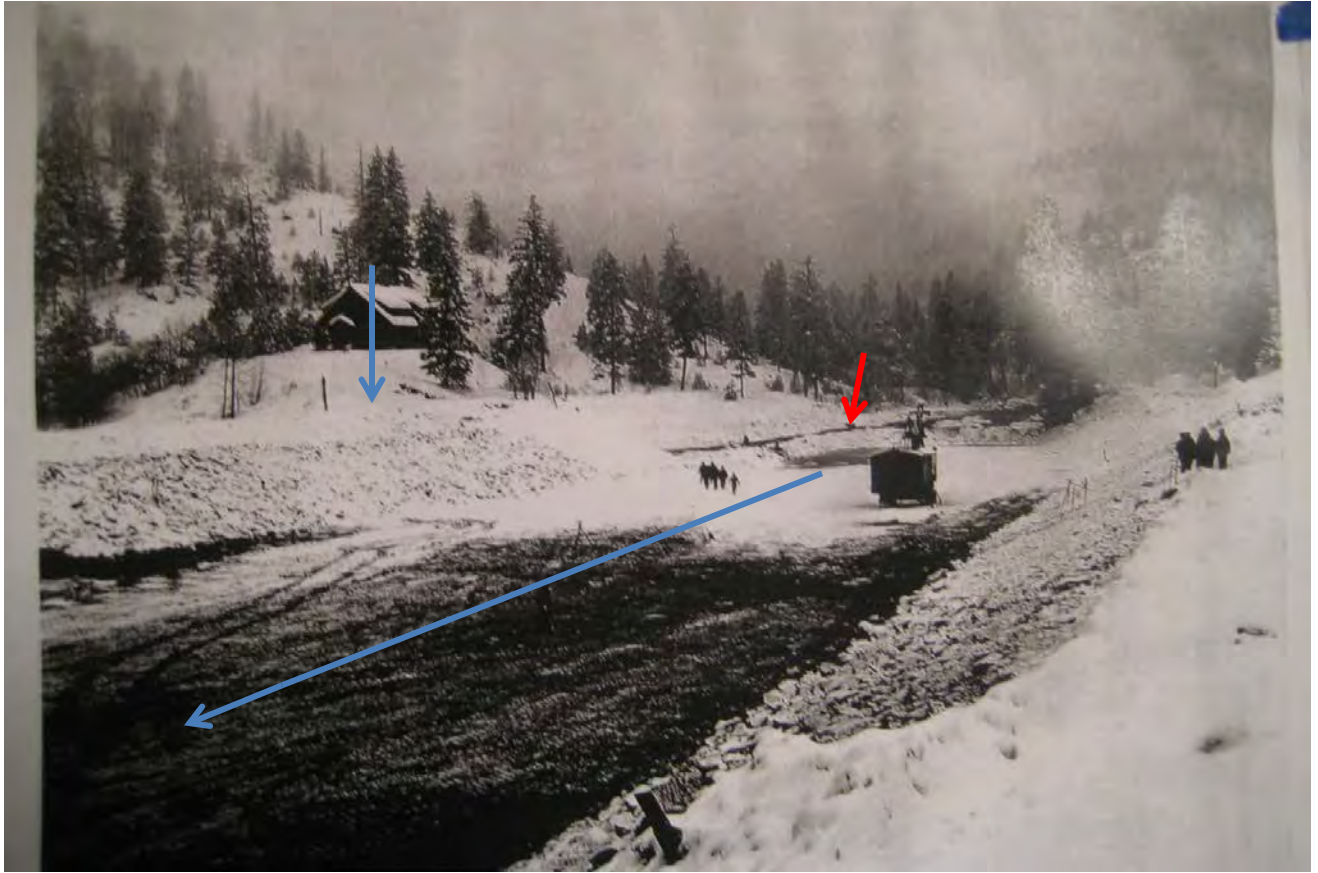
(Figure 6) This is a photo of the south end of the Hatchery Canal looking south in the winter of 1939. The Canal is close to being completed. Icicle Creek has been crowded in its natural bed against its southern shore by a dike so that work on the canal can proceed. The dike on the left side of the canal has been completed. Harriet Bullitt's current residence is the building in the background.

Dam 2 is located behind the dike and is not visible. Dam 2 is located at the end of the vertical blue arrow. When Dam 2 is closed Icicle Creek water flows into the Canal. An arrow shows the direction of flow when Dam 2 gates are closed.

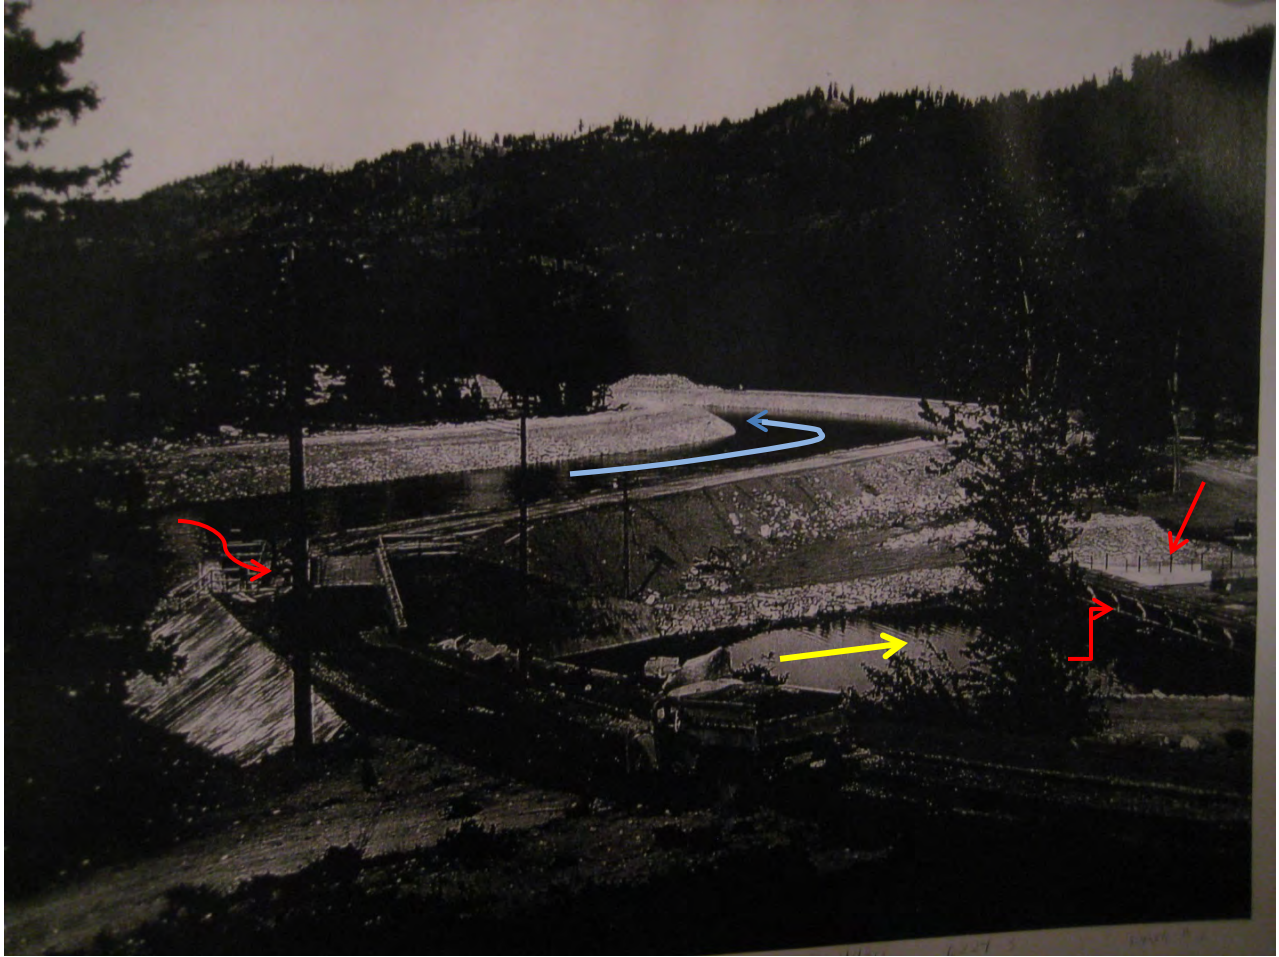
(Figure 7) This photo was taken in the summer of 1939 looking north from the south end of the Hatchery Canal. The canal is full of water. Direction of water flow is shown by the blue arrow. The construction of Dam 2 appears to still be underway (the red S curved arrow). The yellow arrow in the pool behind Diffusion dam 2 points to the direction of flow in the natural bed of Icicle Creek. A completed Diffusion Dam 2 (angled red arrow) and its associated flume (straight red arrow) can be seen at the far right of the photo.

A dike was constructed on the outside of the turn of the Canal since this portion of the Canal occupies the upstream portions of natural high flood channels in the natural bed of Icicle Creek.

The 1990 flood breached the dike on the outside turn of the canal shown in this photo, eroding a 200 foot wide path through the dike to a level even with the bottom of the Canal.

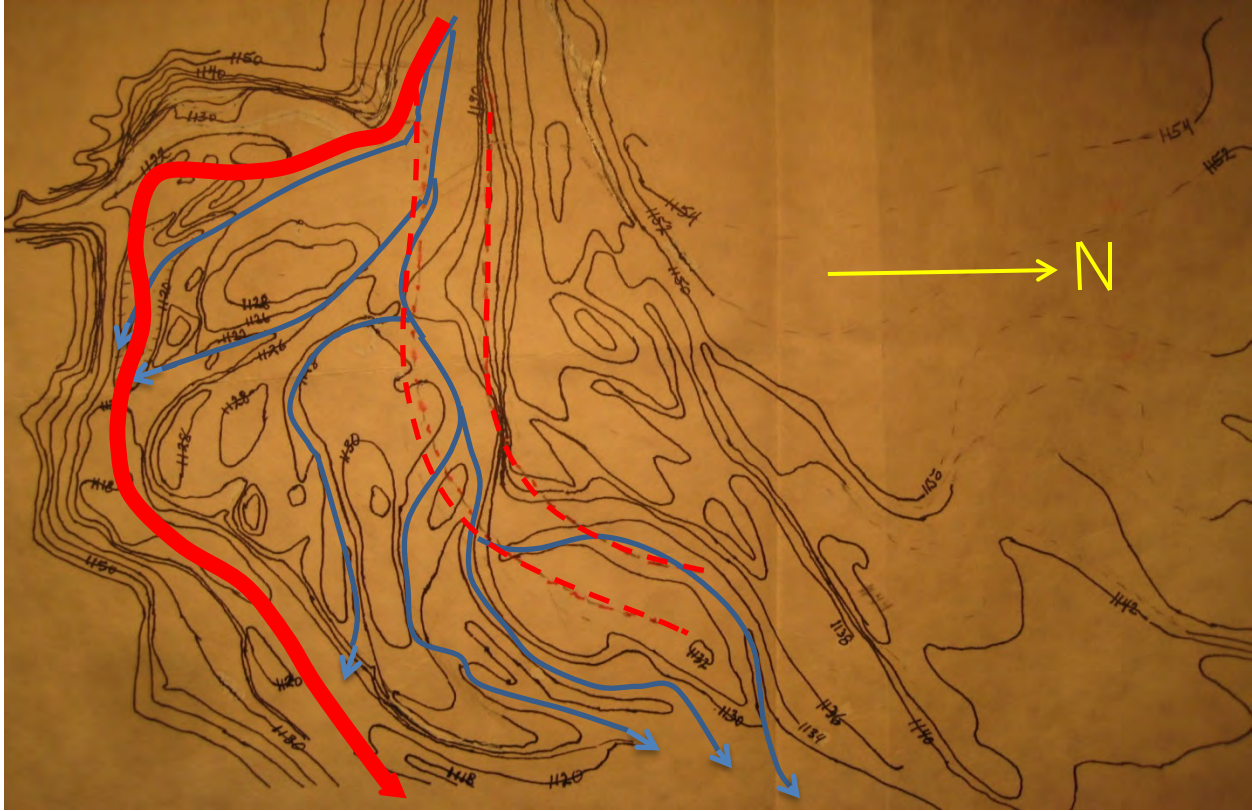
(Figure 8) This is a photo of a topographic map of Icicle Creek where the Hatchery Canal was constructed. The parallel dotted red lines show the proposed path of the Hatchery Canal.

This map clearly shows where historical flooding of Icicle Creek formed the topography outside the main natural channel. (The main natural bed of Icicle Creek is shown using one wide red arrow and the flood areas are shown in blue arrows). The topographic map shows that the Canal occupies the natural bed of Icicle Creek at the extreme west end of the Canal and that the Canal occupies portions of the upstream ends of historic flood channels.

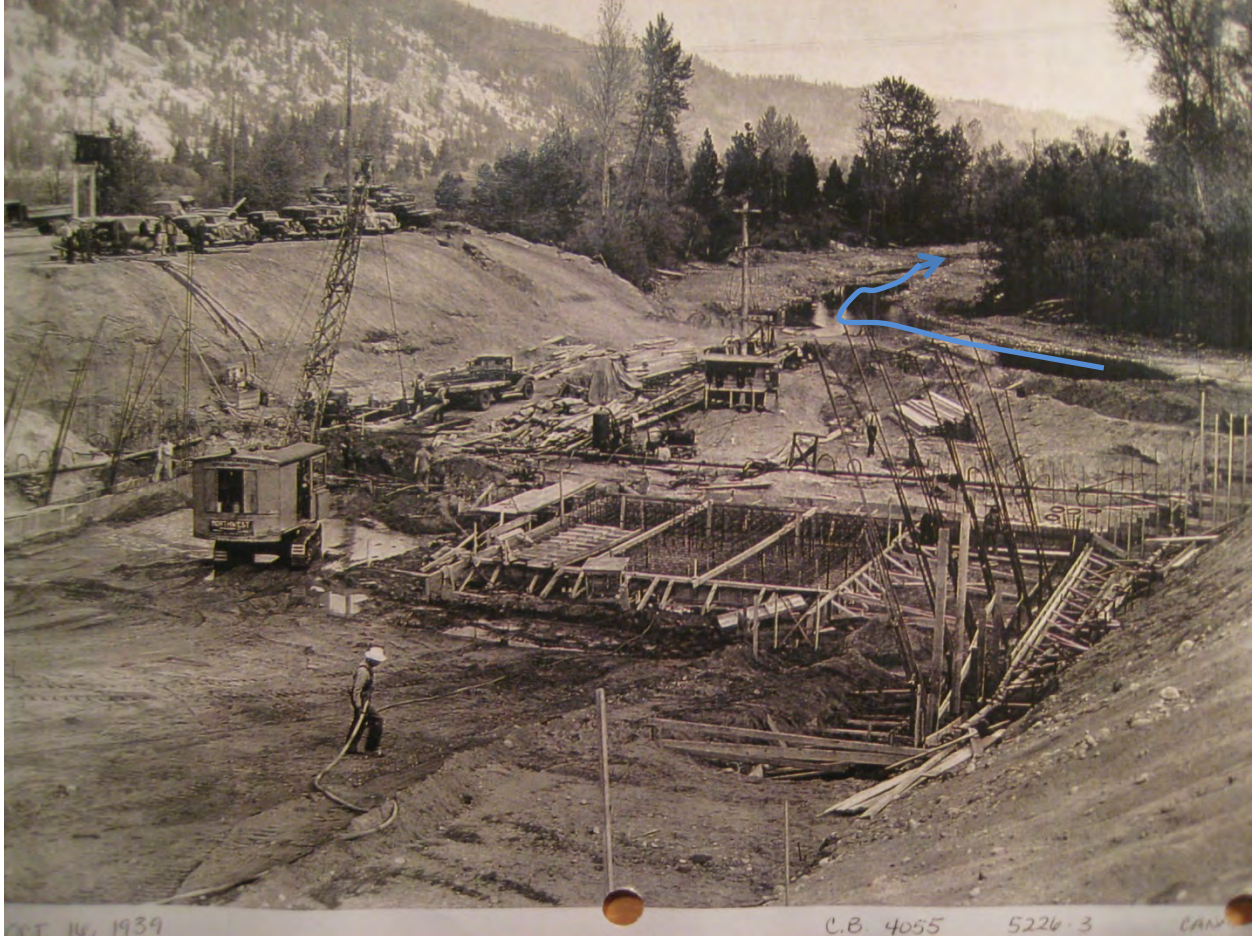
(Figure 9) This is a photo of the north end of the Hatchery Canal under construction in 1938. The design of the Canal was to keep the bottom of the canal at elevation 1124 which is the elevation of the bottom of Icicle Creek at the south end of the Canal. The spillway dam served to get water from an elevation of 1129 to the elevation of Icicle Creek at the north end of the Canal (1118) without the canal water eroding a path to elevation 1118. Icicle Creek can be seen in the background of this photo. (The blue arrow shows the direction of stream flow).

Also, notice the fine material on both banks of the canal indicating this may be low ground water-producing surficial deposits.

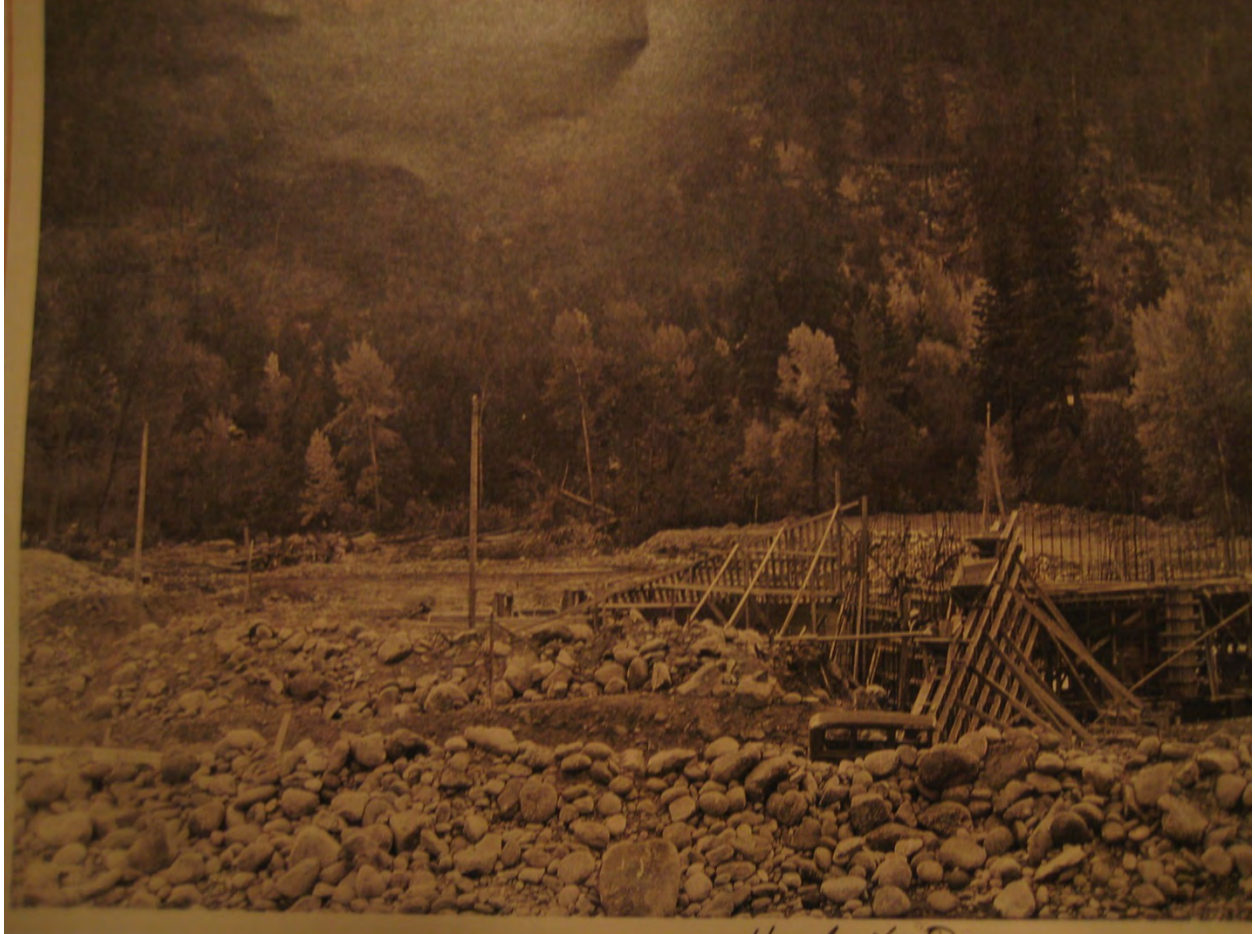
(Figure 10) This photo shows Dam 2 (also referred to as the Headgate Dam) under construction in 1938. This photo shows the type of material underlying this area of the Leavenworth Valley. It is obvious that the underlying material is composed of small boulders that appear to be water worn. It is not hard to imagine that this area is a place of aquifer recharge. Compare this to Figure 4, on page 5, a photo of approximately the same area in 1929 (that photo was taken from a position slightly upstream and to the left of this one)

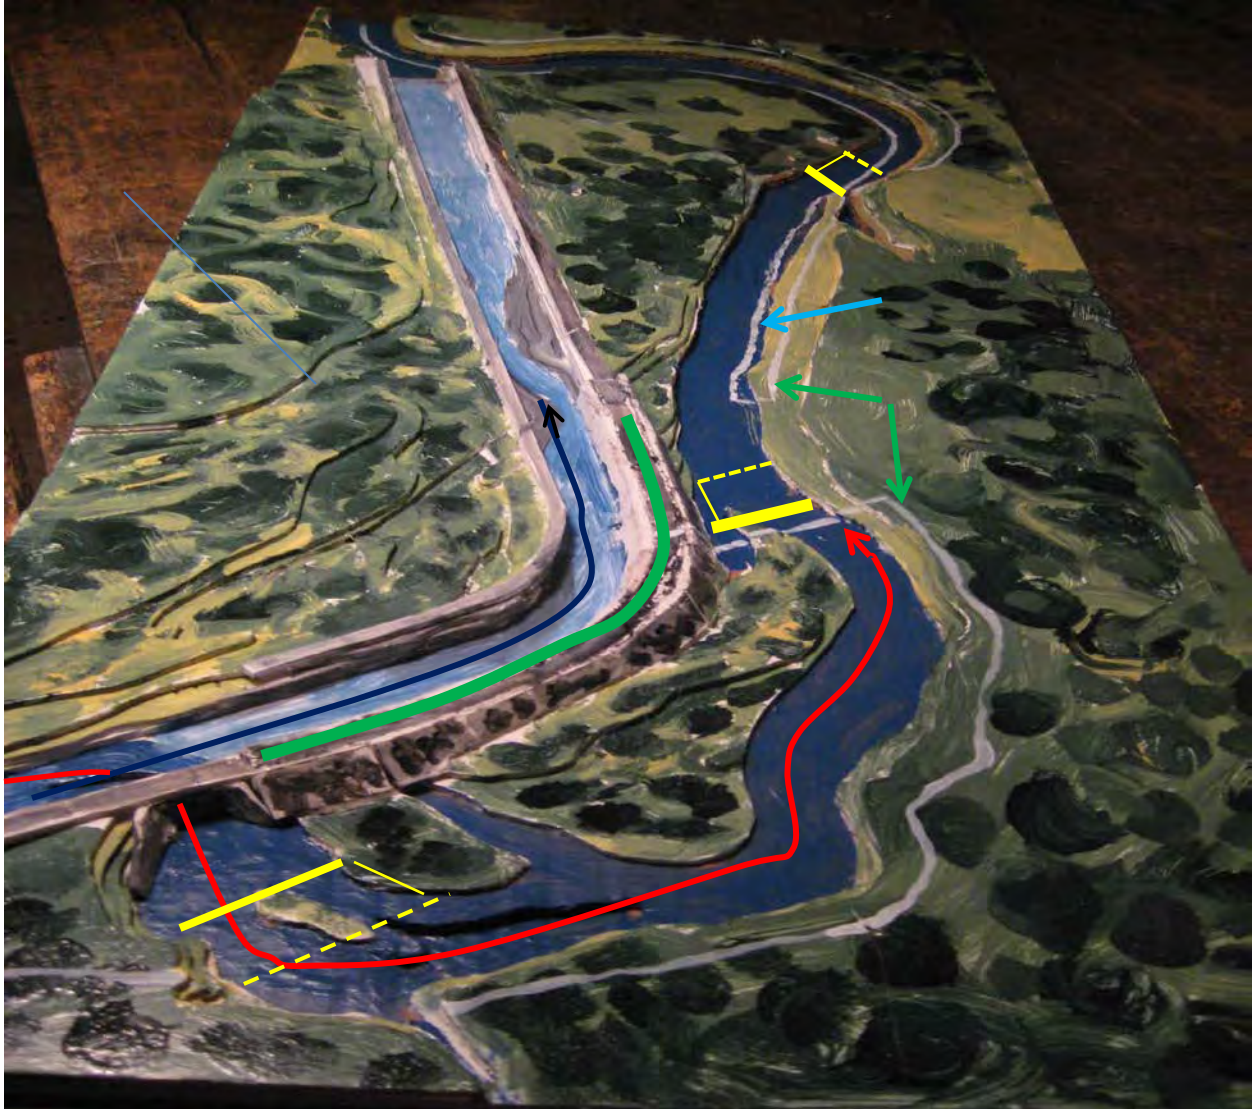
(Figure 11) This is a photo of a model of the Hatchery Canal and the natural bed of Icicle Creek looking north. The model has a 2 to 1 vertical exaggeration.

The blue arrow points to the white line showing the thalweg of the stream that serves as the property boundary between the USFWS and Private property. The two green arrows point to easement boundaries between the USFWS and private property. The black arrow shows the direction of water flow in the Hatchery Canal. The red arrow shows the direction of water flow in the original bed of Icicle Creek. The wide green line follows the road that is built on top of the dike. The dike is made of fill and riprap and is on top of old flood channels. It is this dike that broke in the 1990 flood. The three solid yellow lines across the natural bed of Icicle Creek show the locations of the diffusion dams. The dashed yellow lines show where the racks were placed and the thin yellow shows the flume that connected the dam with the rack. The Icicle Creek Watershed Council removed these three structures in 2003.

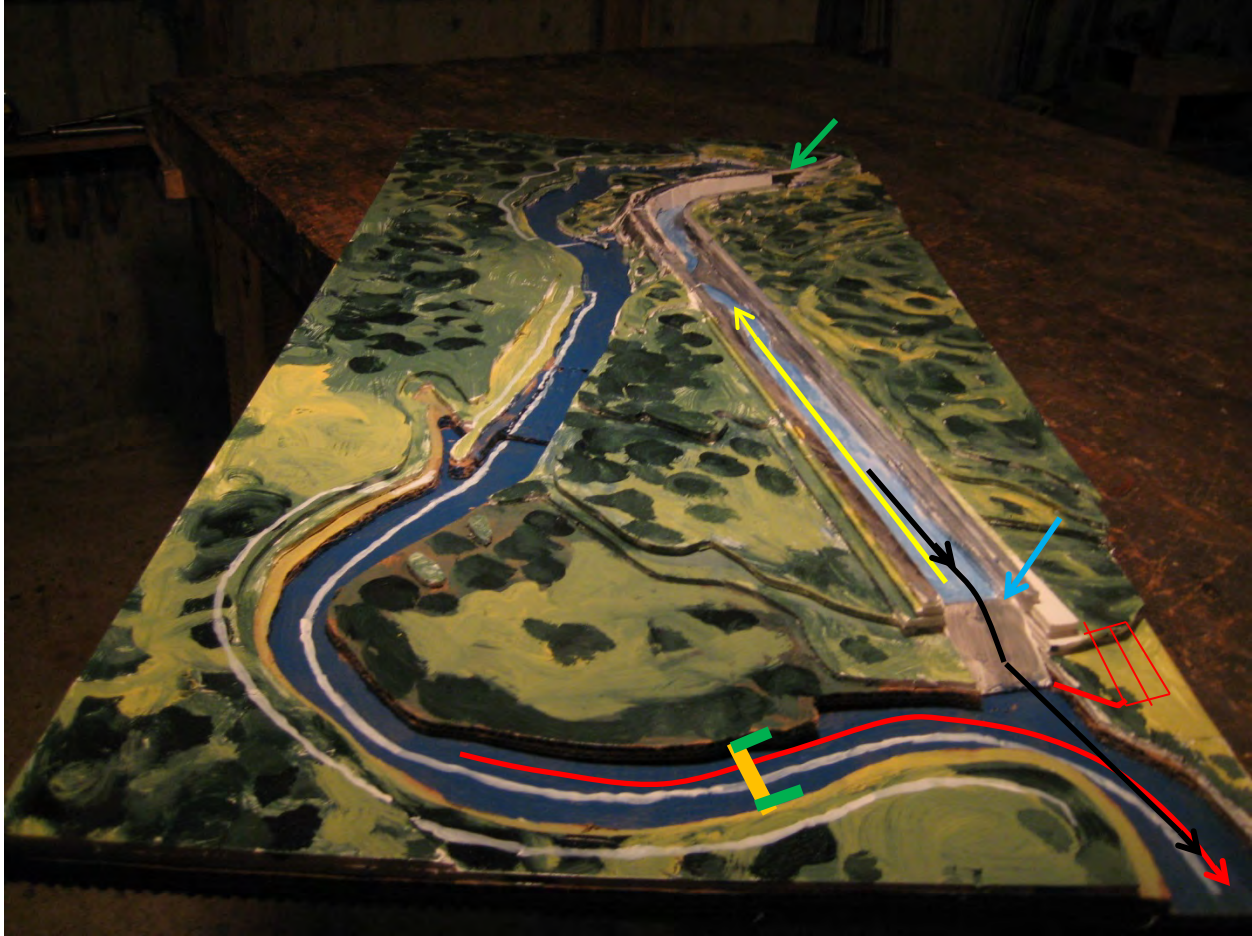
(Figure 12) This is a photo of the same model as in Figure 11 except it is taken looking south. The green arrow points to Dam 2. The wide yellow line across the natural channel of Icicle Creek is diffusion dam 5. There was no rack or flume associated with Dam 5. Two fish ladders (wide green lines at both ends of Dam 5) are built into dam to allow fish upstream.

In the mid 1960's it was obvious that the holding pond idea was not going to succeed. A fish ladder was bolted to the face of the spillway dam but it was too steep. The blue arrow points to the spillway dam which is impassable to fish.

The black arrow going over the spillway dam shows the direction water flows in the canal when Dam 2 gates are closed. The yellow arrow in the canal points to the direction the canal drains when Dam 2 gates are open and flow in Icicle Creek is less than 300 cfs.

A fish ladder (red line) was built in 1979 at the base of the spillway dam. There are two holding ponds associated with the ladder (thin red lines).

The pool at the base of the spillway dam is where the Tribes fish.

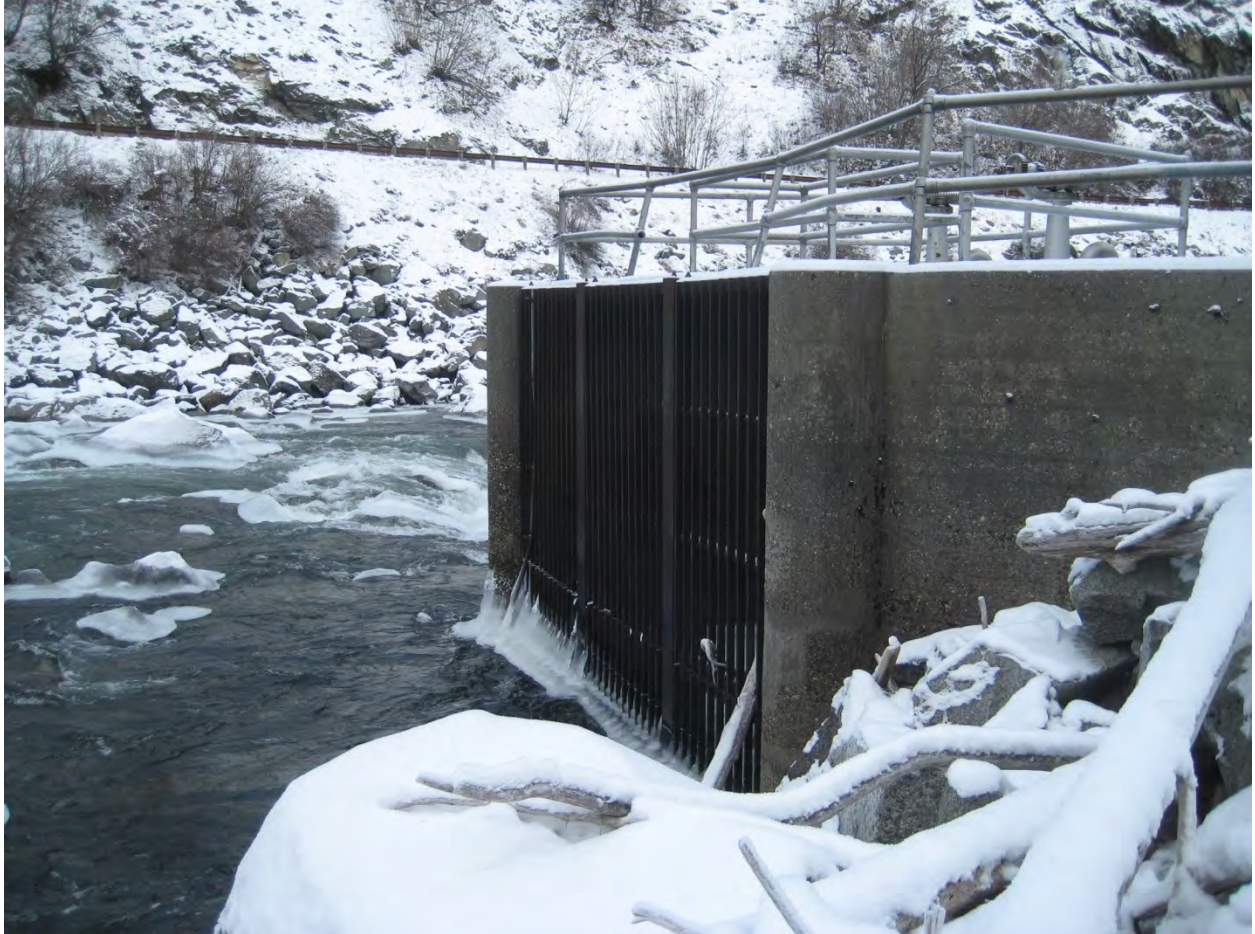
(Figure 13) This photo shows the headworks of the Wenatchee Canal. The photo was taken in the winter of 2013. The road across the river is Highway 2 in Tumwater Canyon about one mile west of Leavenworth.

This canal was designed to deliver 300 cfs.

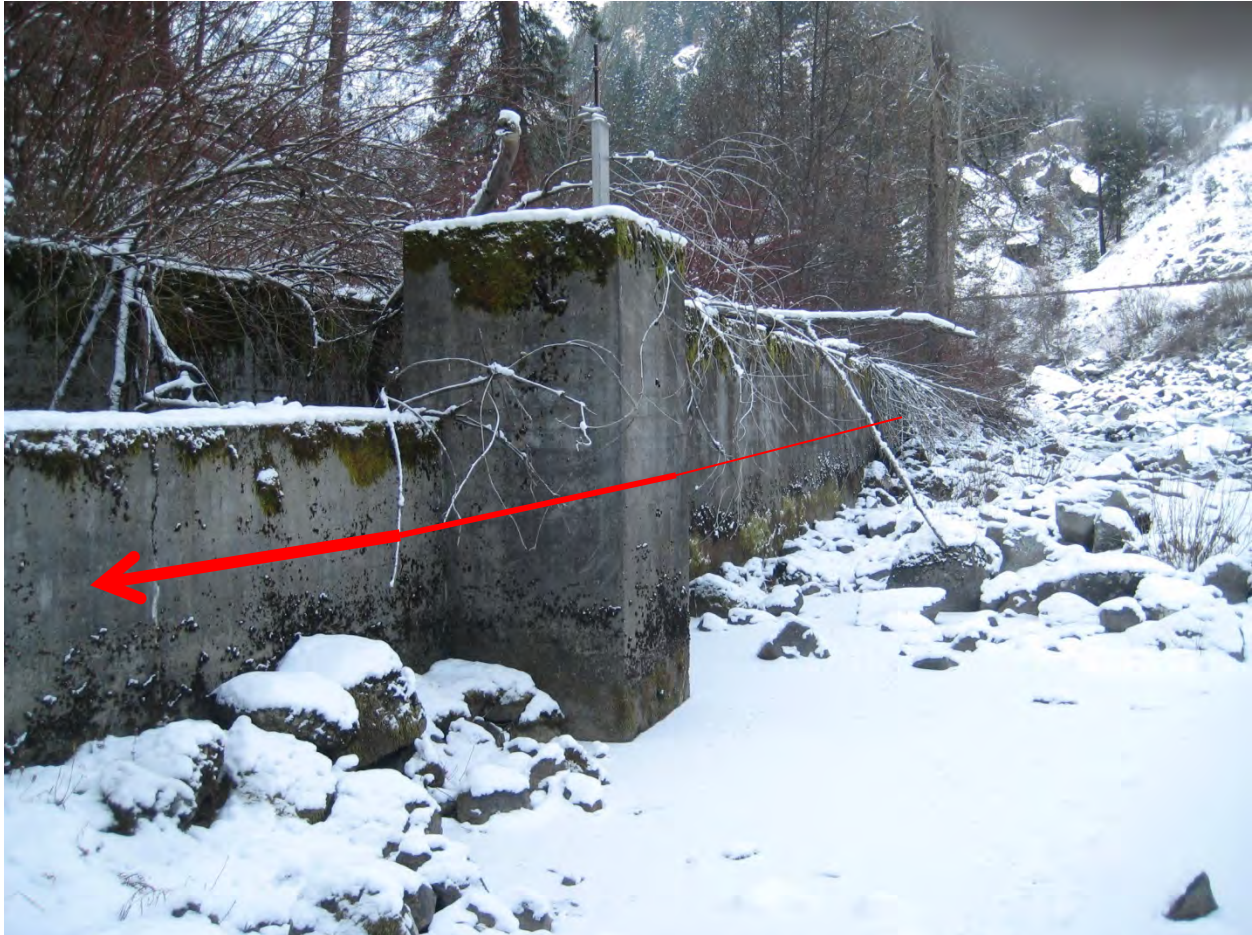
(Figure 14) This is a photo taken in 2013 of the Wenatchee River Canal. This shows the canal as it leaves the Wenatchee River in Tumwater Canyon. A large steel drum gate is mounted in this section of the canal to control water volume at this point in the canal. The red arrow shows direction of water flowed.

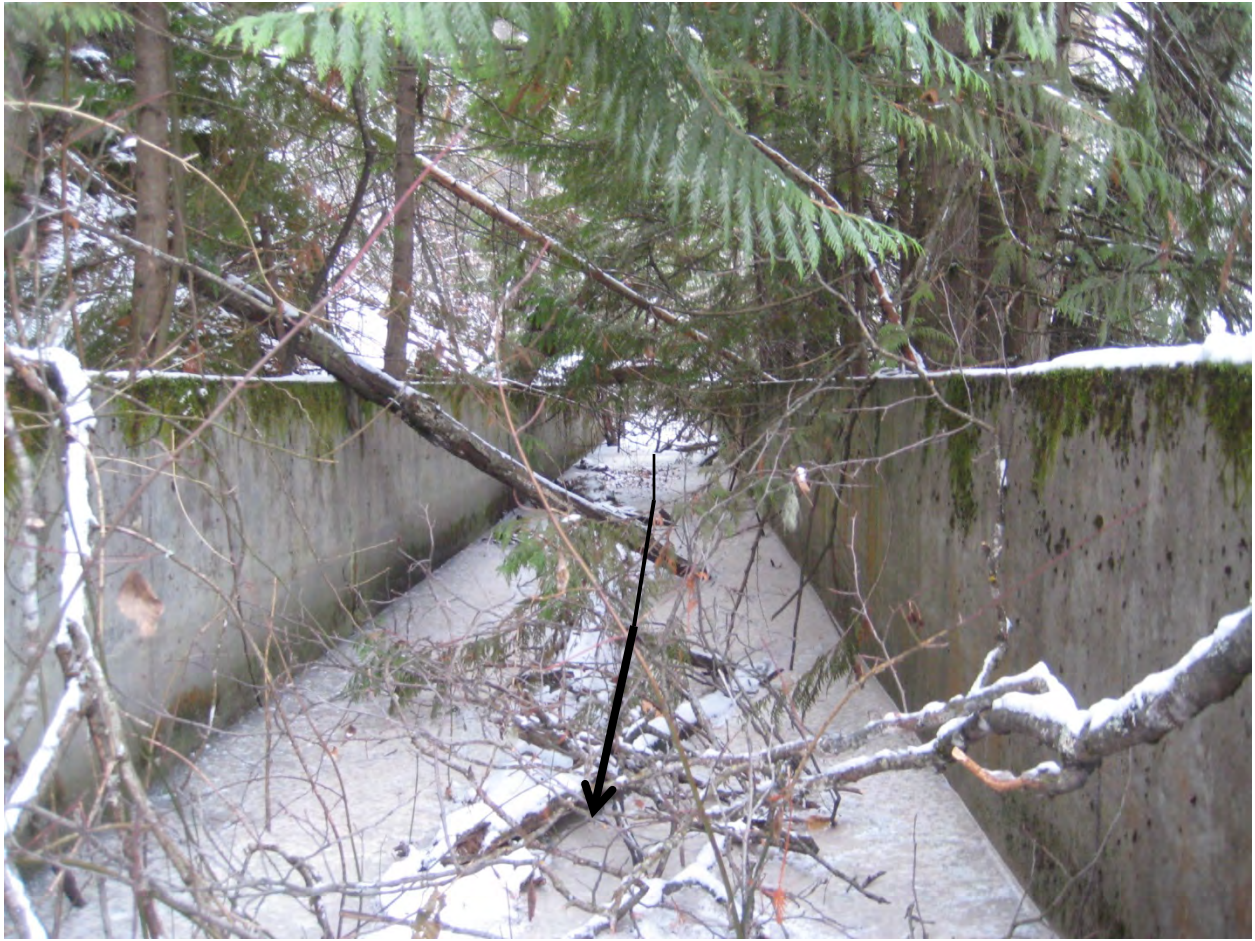
(Figure 15) This is another photo taken in 2013 of what is left of the Wenatchee Canal. The canal was abandoned within a few years after operating because Wenatchee River water was too warm and the plan to pump Wenatchee water to the Icicle Irrigation canal failed.

The photo is of the upper last section of the canal looking up the canal. The black arrow shows flow direction.

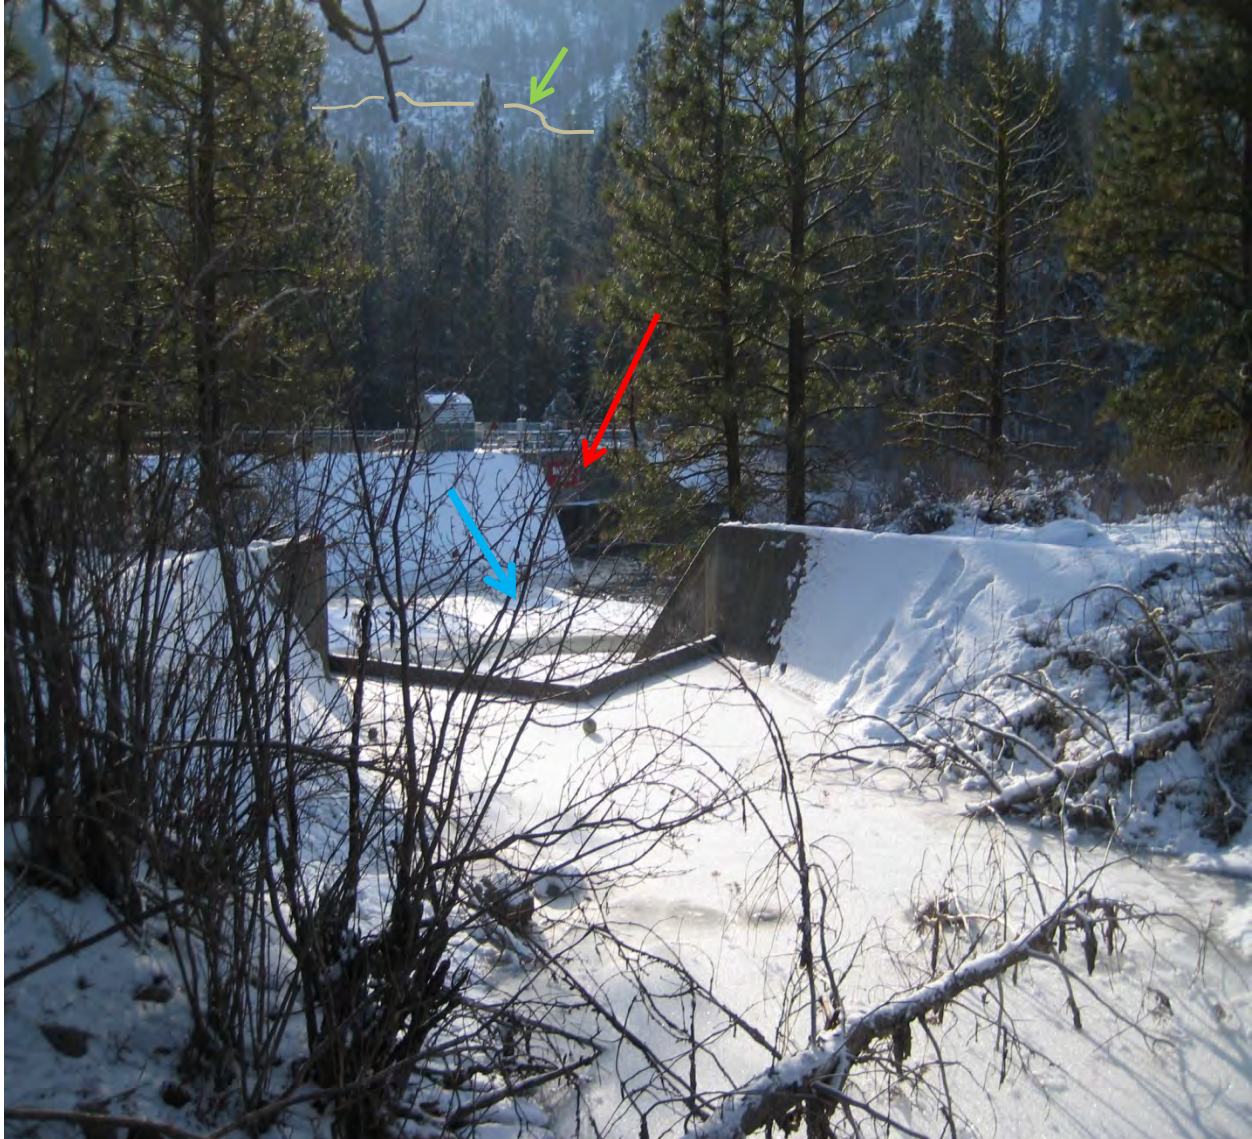
(Figure 16) This photo, taken in 2013, shows the southeastern end of the Wenatchee Canal. The plan was to discharge Wenatchee River water into the southern end of the Hatchery Canal shown here in the center of the photo, where it would flow through Dam 2 (Headgate Dam) to the pools holding anadromous fish until they were ready to spawn. The Headgate dam is across the Hatchery Canal in this photo. (A red arrow points to it).

The blue arrow points to the bed of the Hatchery's Canal.

The green arrow (upper part of photo) points to the approximate location of the Icicle / Peshastin irrigation canal. The original proposal was to pump Wenatchee River water delivered to the Hatchery Canal (Elevation 1130 ft. shown here) to the Icicle /Peshastin Irrigation Canal (Elevation 1400 ft.) in exchange for the Districts full water right of 117 cfs

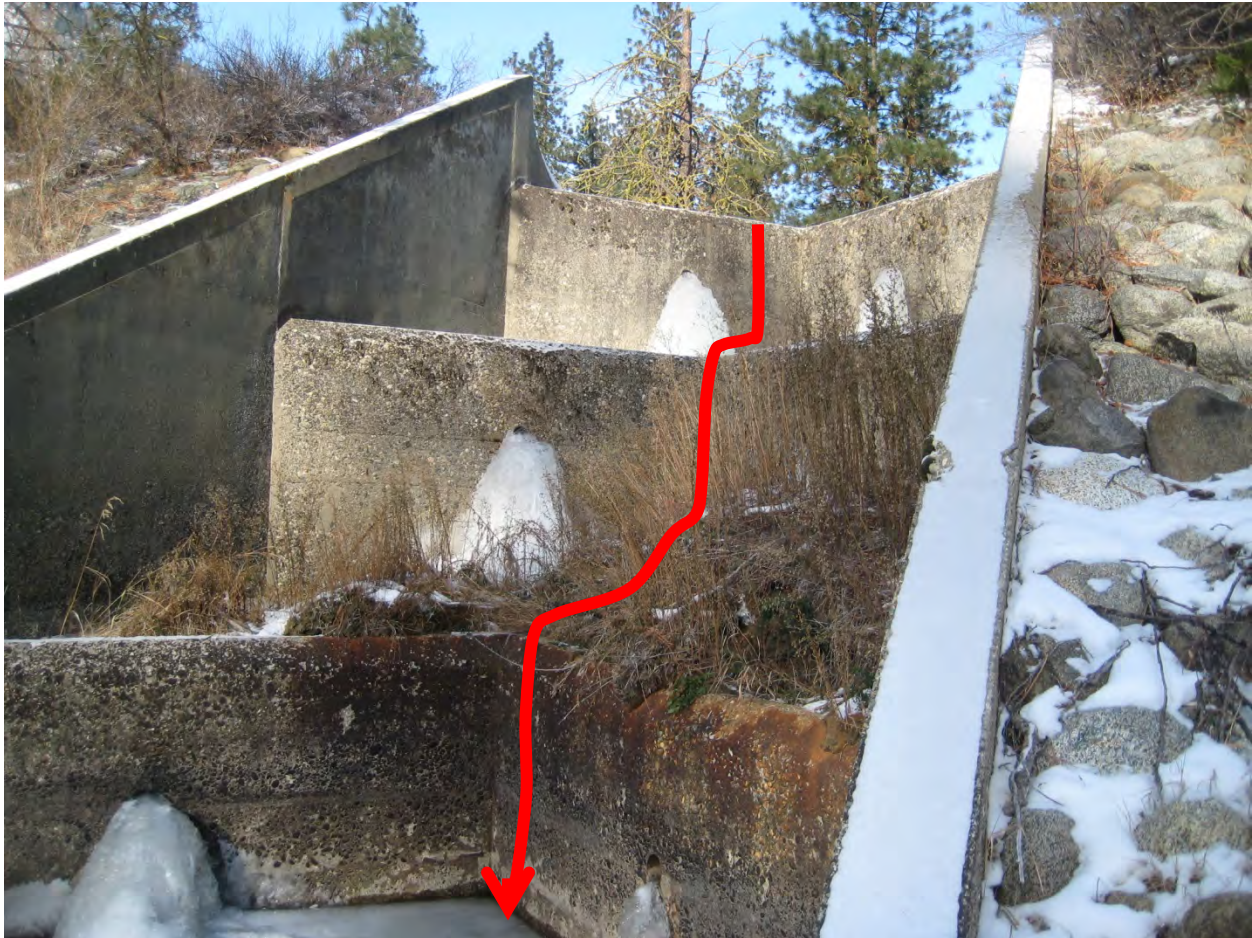
(Figure 17) This is the discharge end of the Wenatchee Canal taken in 2013. The series of steps is a design to get water from a higher elevation to a lower elevation without eroding the bottom of the canal. The red line with an arrow at the end shows how water cascaded to the floor of the Hatchery's Canal.

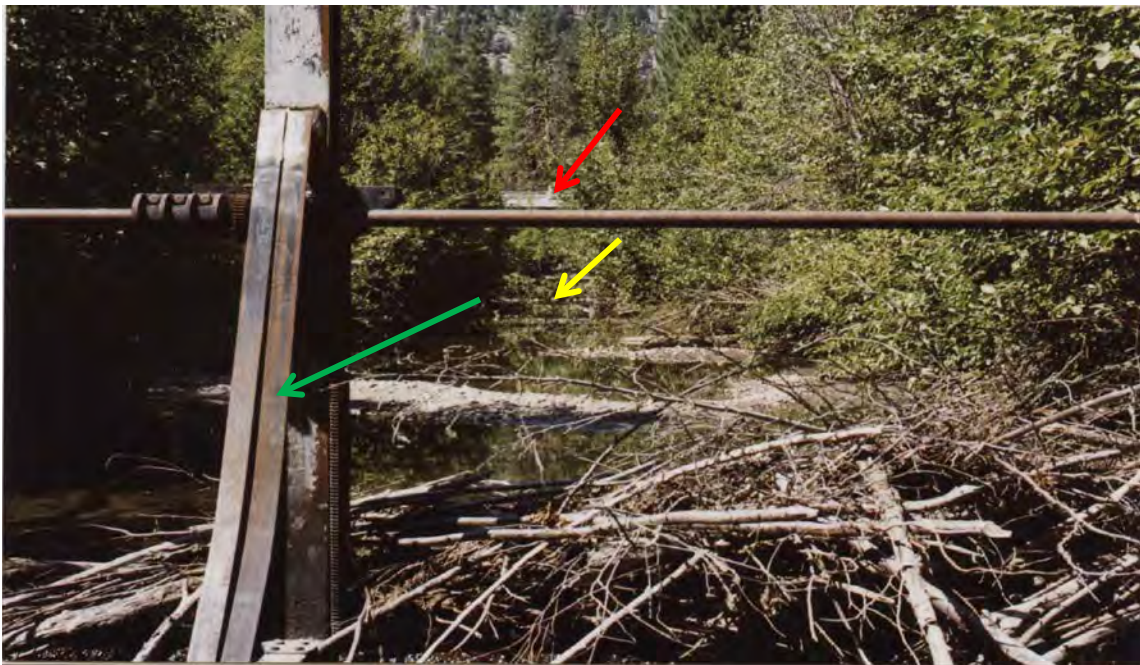
(Figure 18) This photo was taken from number three rack looking upstream. The red arrow points to Dam 2. The yellow arrow points to Diffusion Dam 2 which can barely be seen. The green arrow points to part of the structure that operated the fish racks.
