**ICICLE CREEK
AND THE
LEAVENWORTH NATIONAL FISH HATCHERY**

January 12, 2014

This forty-two page summary is a brief history of the relationship between Icicle Creek and the Leavenworth National Fish Hatchery.

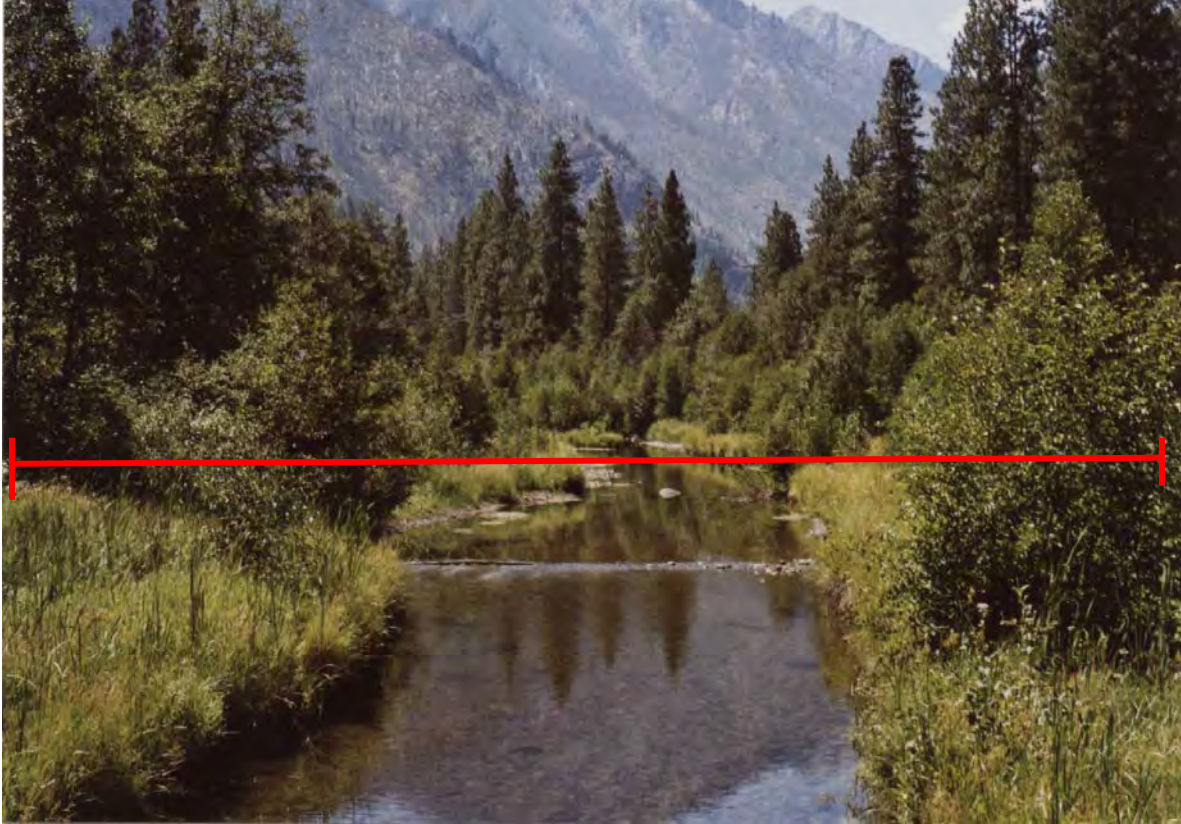
(Figure 19) This photo is looking upstream. The photo was taken in 2001 from the walkway built on top of Diffusion Dam four. The red line shows the original natural width of Icicle Creek in this location (120 feet). The alder trees and grass have taken root in sediment that collected in the fish holding pools behind the diffusion dams before the 1990 flood.

Water in this photo is coming from Mountain Home Creek (1/3 cfs) and about 5 cfs from Hatchery Canal leakage. The Tainter gate seals at Dam 2 had deteriorated by this time so that water leaked around the gates. Water volume is between 5 and 40 cfs (when the gates are closed) depending on water height behind the dam.

Water in this photo is flowing at about 10 cfs.

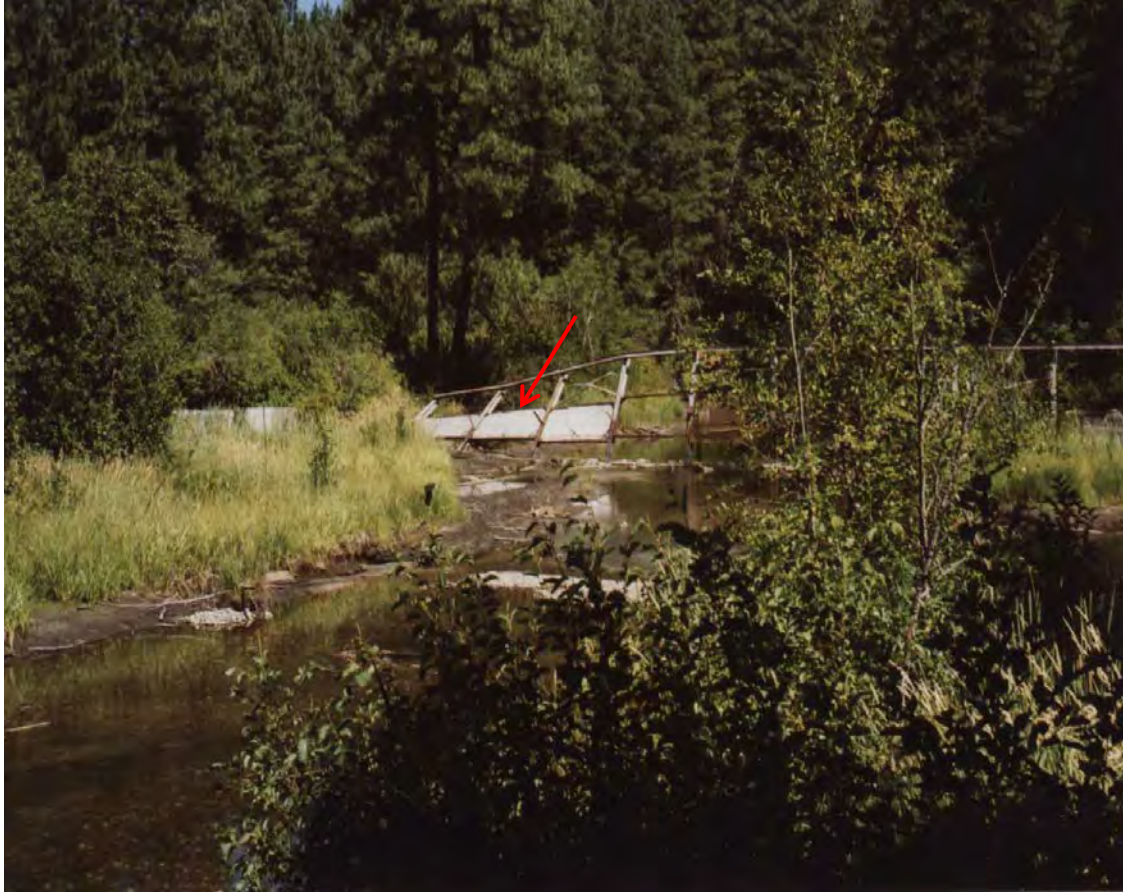
(Figure 20) This is a photo taken in 2001 from the walkway on Diffusion Dam 4 looking downstream. The rack was damaged by the 1990 flood (red arrow).

Fish were held between Diffusion Dam 4 and the rack. The pond was created by placing stop-logs in Diffusion Dam 5 (downstream from here but out of sight). Diffusion Dam 5 stop-logs have been removed in this photo so there is no pool

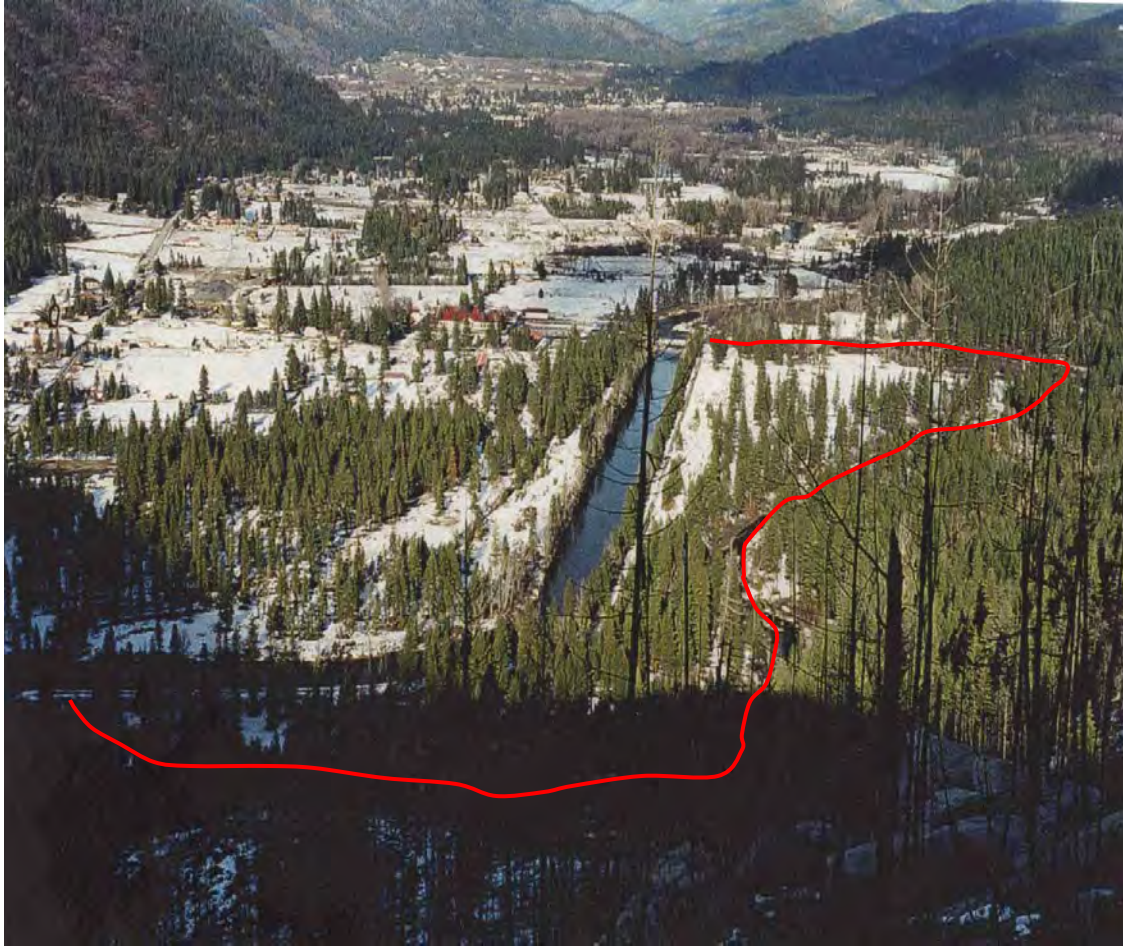
(Figure 21) This photo was taken in November 2002 from Mountain Home Road. The Hatchery Canal is clearly visible. The natural channel of Icicle Creek can barely be seen (indicated by the red line).

It is easy to imagine someone not familiar with Icicle Creek mistakenly concluding that the Canal is Icicle Creek. It is full of water. It is about 100 feet wide. It is also understandable to imagine interpreting the natural channel of Icicle Creek as a minor “side channel”. The natural Channel had hardly any water in it and was small and crowded with red osier, maple and alder.

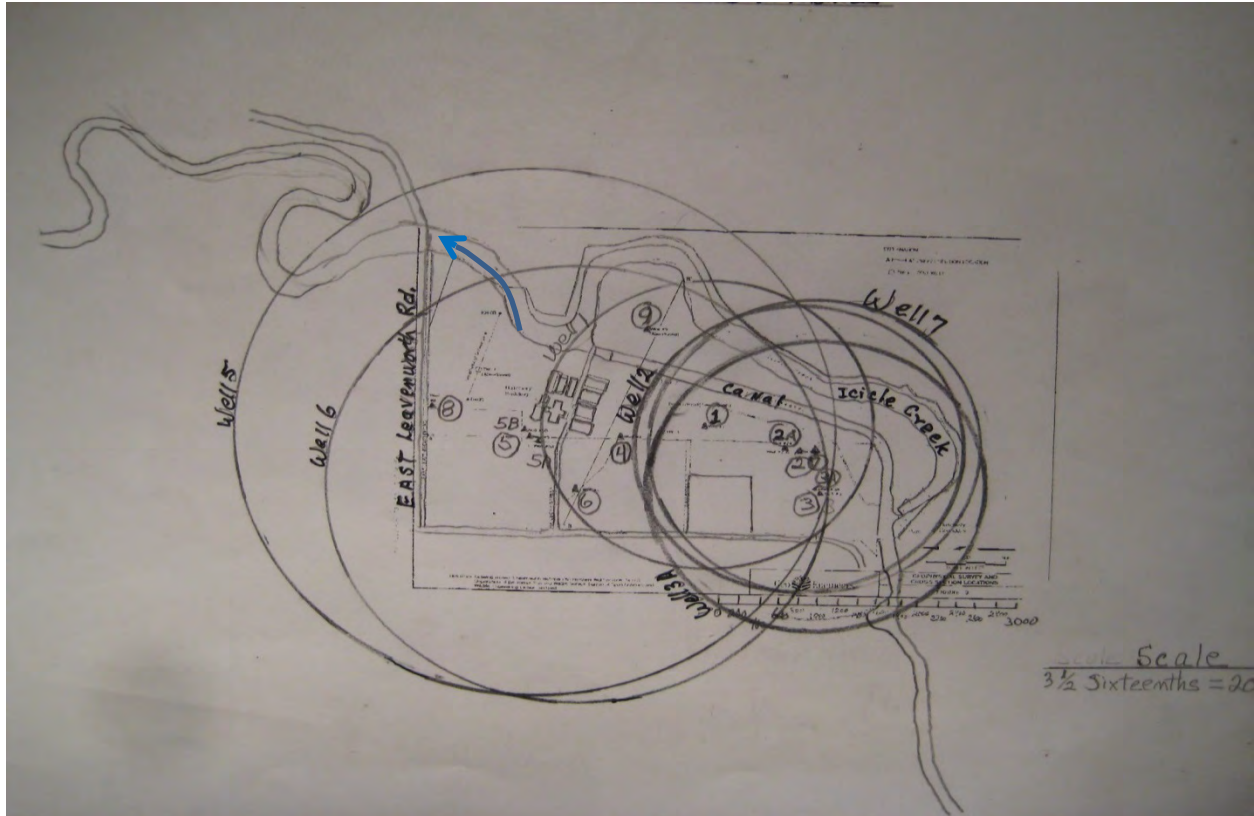
(Figure 22) This map shows the extent to which Hatchery wells reach. The blue arrow shows flow direction of Icicle Creek.

What follows is a map of the locations of the LNFH wells and the cones of depression, otherwise known as areas of influence as described in the 1995 GeoEngineers report:

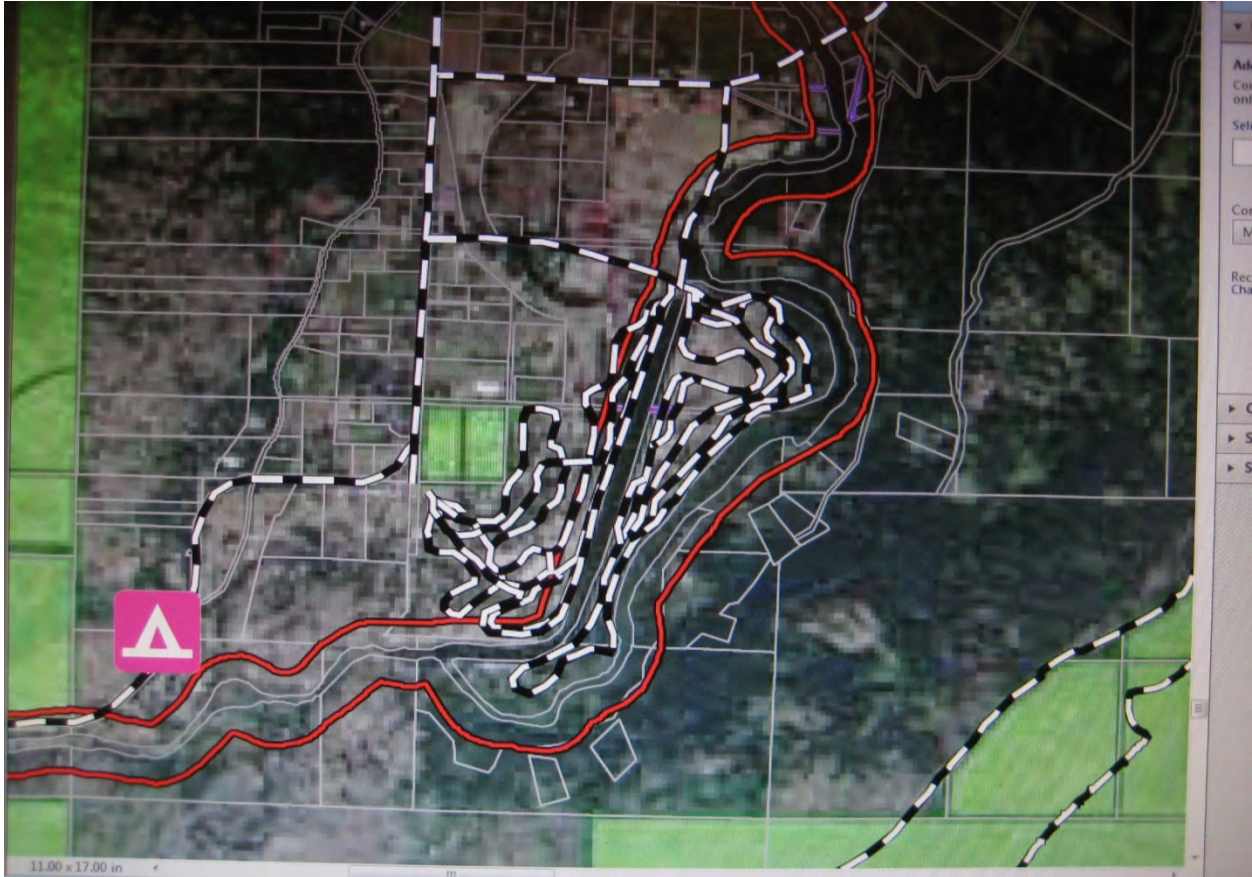
(Figure 23) This is a photo of an enlargement of a map from Appendix A of Chelan County's Shoreline Master Program Update August 31, 2010.

In this plan, shoreline jurisdiction boundaries are delineated by drawing red lines on maps around waters of statewide significance in Appendix A of the SMP. When these lines were drawn for Icicle Creek the lines spread apart at the intersection of the canal and the natural bed of Icicle Creek at Dam 2 to include both the natural bed and the Hatchery Canal (Figure 23).

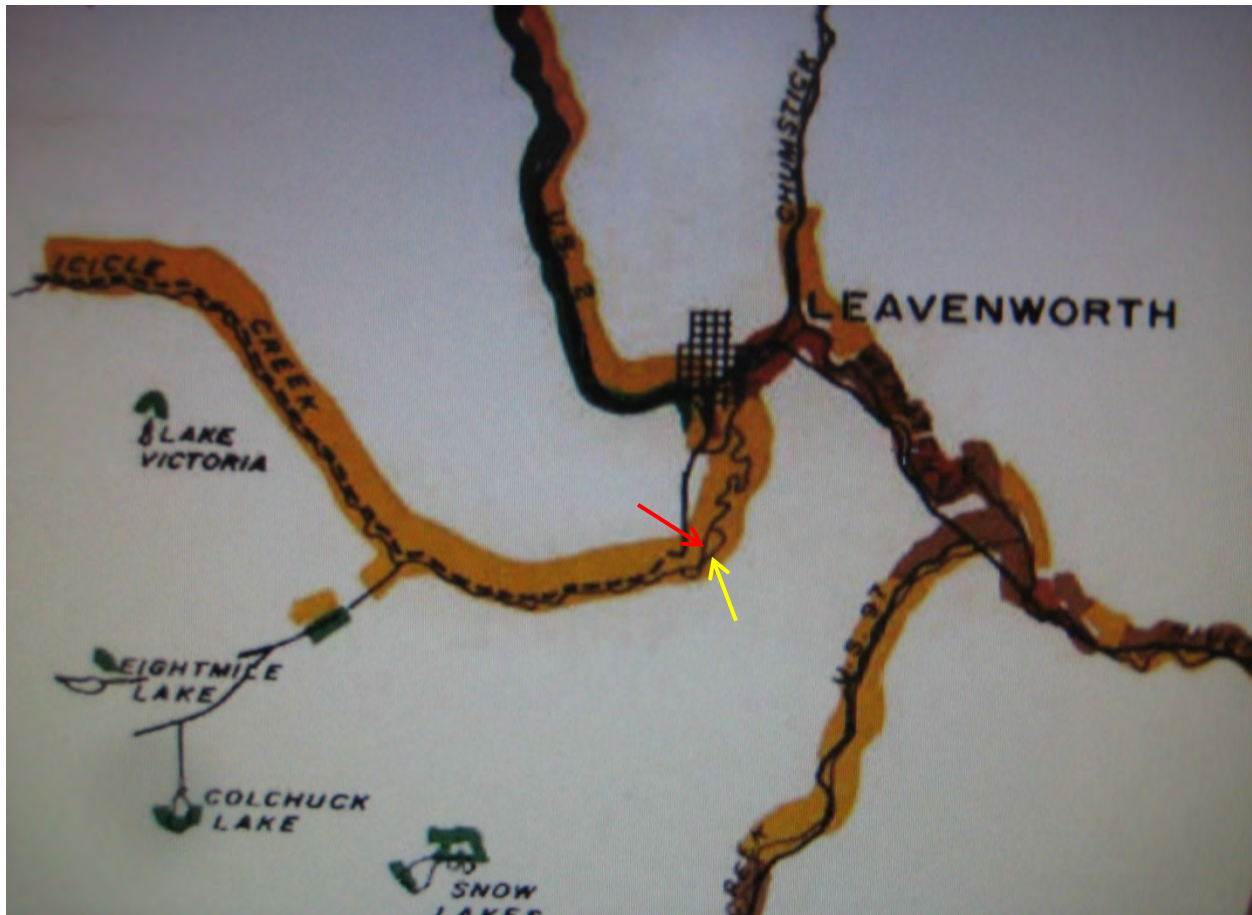
(Figure 24) Figure 24 shows the 1975 environmental designation. A red arrow points to the canal. A yellow arrow points to Icicle Creek where the holding ponds were built.

The Shoreline Management Act was passed by the Legislature in 1971. The 1975 the holding ponds in the natural bed of Icicle Creek were still being used to hold fish when the Chelan County SMP was adopted in 1975. The environmental designation on Leavenworth National Fish Hatchery property included the Hatchery Cana in 1975. (Figure 24)

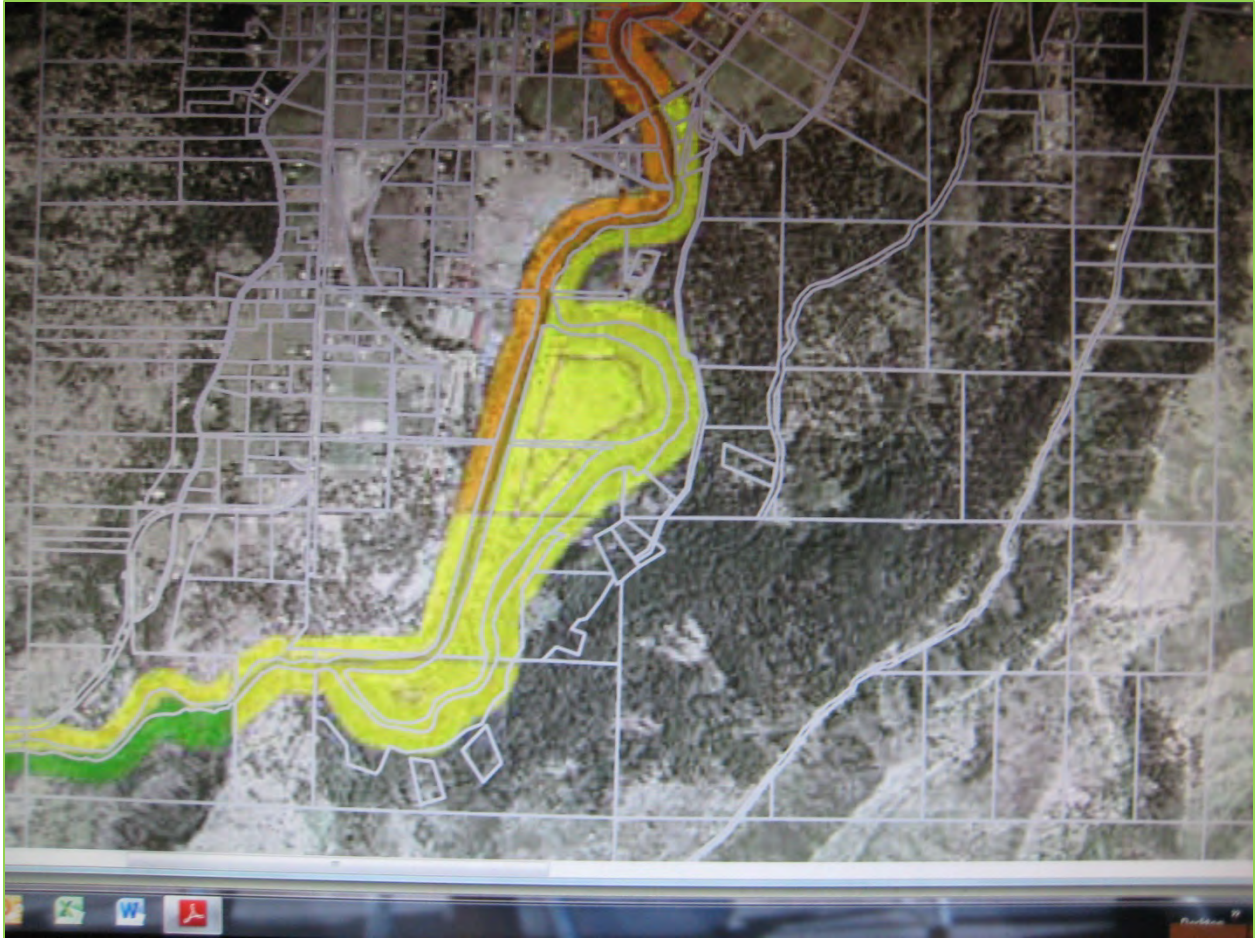
(Figure 25) This photo shows the current environment designations on Leavenworth National Fish Hatchery and private property. The Natural bed of Icicle Creek is designated as Conservancy environment. All of the east side of Hatchery's Canal is designated as Conservancy environment. One half of the south end of the canal on the west bank is conservancy and one half of the north end of the west bank of the canal is rural.

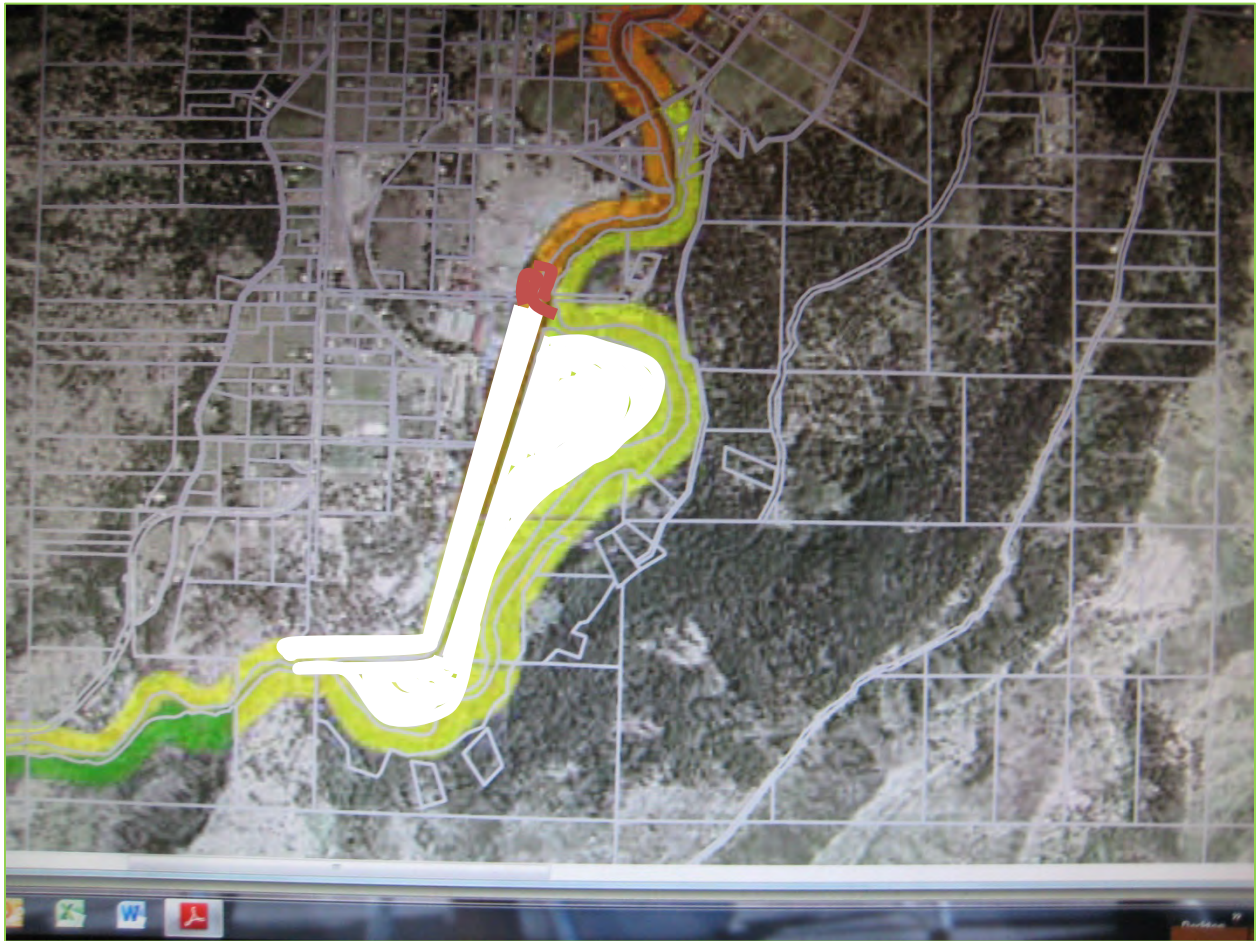
(Figure 26) This is a proposed amended Chelan County Shoreline Master Program of Icicle Creek showing reallocated environmental designations between RM 3.8 and RM 2.8.

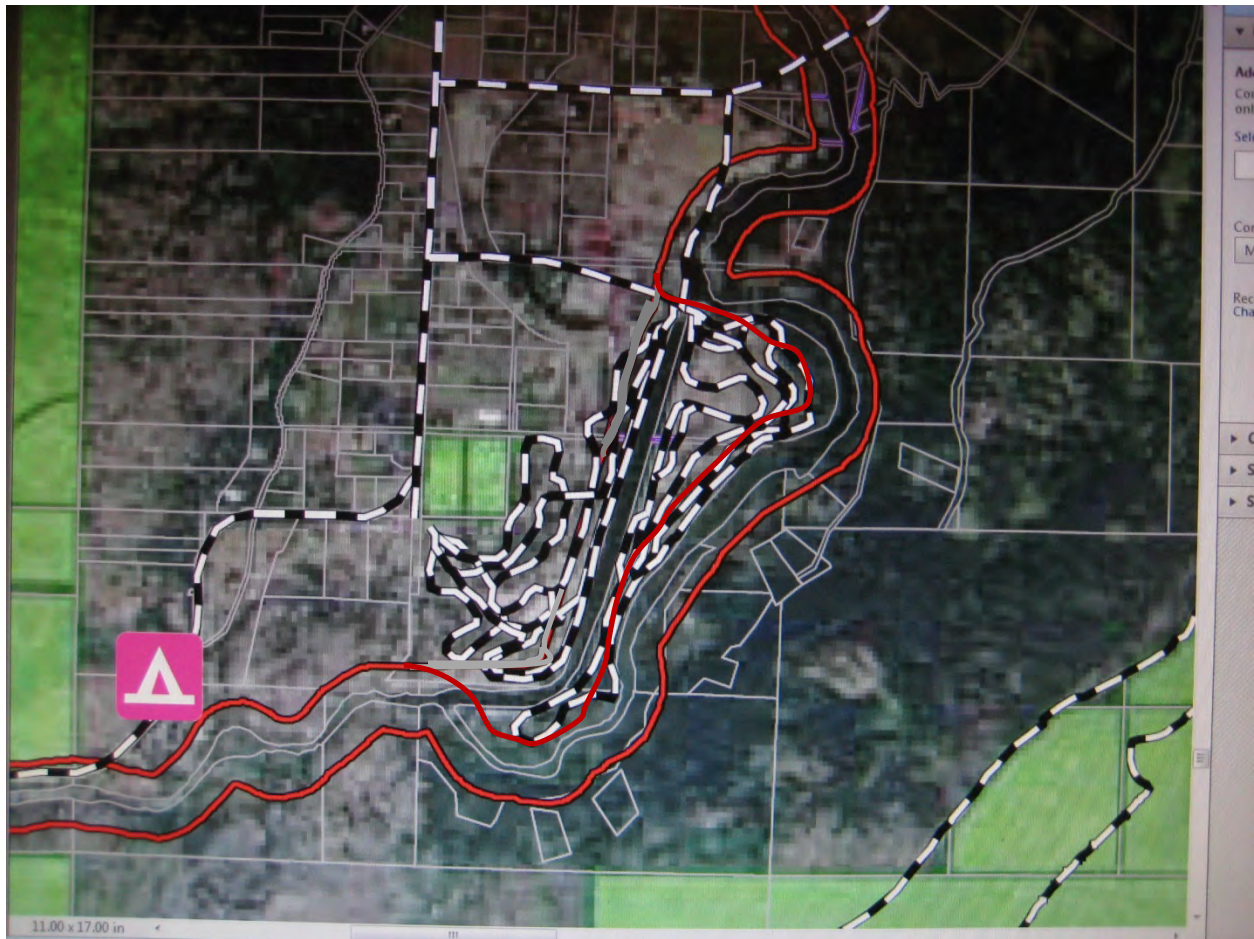
(Figure 27) This is a proposed amended Chelan County Shoreline Master Program of Icicle Creek showing redrawn jurisdiction boundaries between RM 3.8 and RM 2.8.
